ERDC/GSL TR-03-24

## **E-Krete™ Polymer Composite Micro-Overlay for Airfields: Laboratory Results and Field Demonstrations**

November 2003

Final report

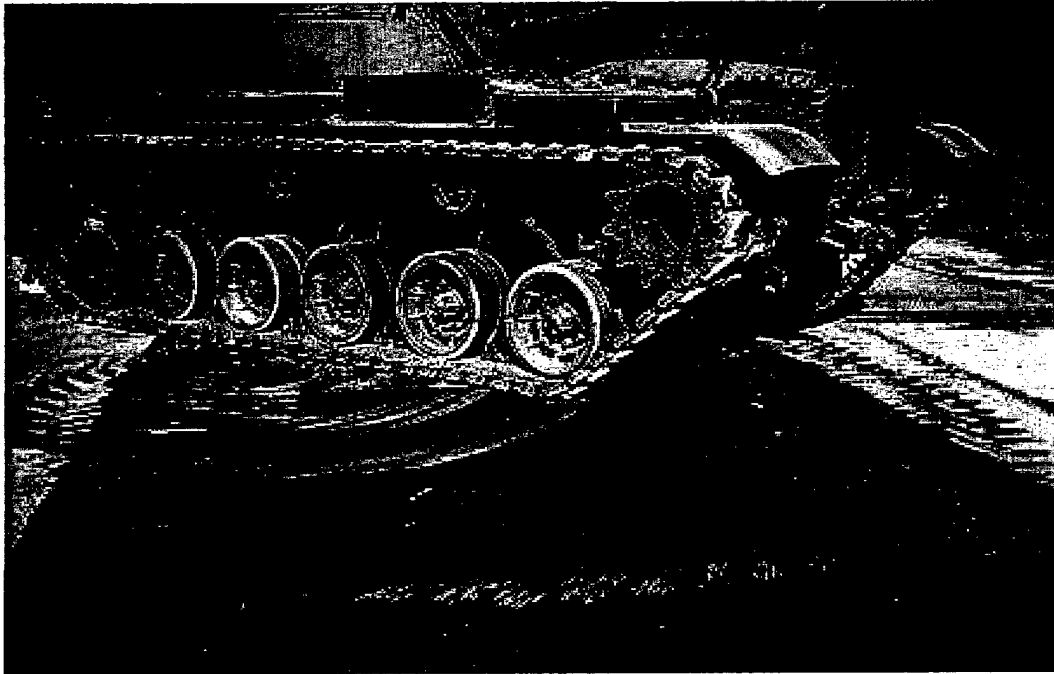
Approximately 10 total pivot steers were conducted on the E-Krete™ surfaces with no delamination from the underlying asphalt. The damage to the E-Krete™ surface was some slight scuffing of the surface in areas with a surface layer of broadcast sand. The sand had sheared loose from the surface and caused scuffing under the tank treads. The areas that had no surface

Figure 3. 106,000-lb M-60 tank conducting pivot steers on E-Krete surface at ERDC

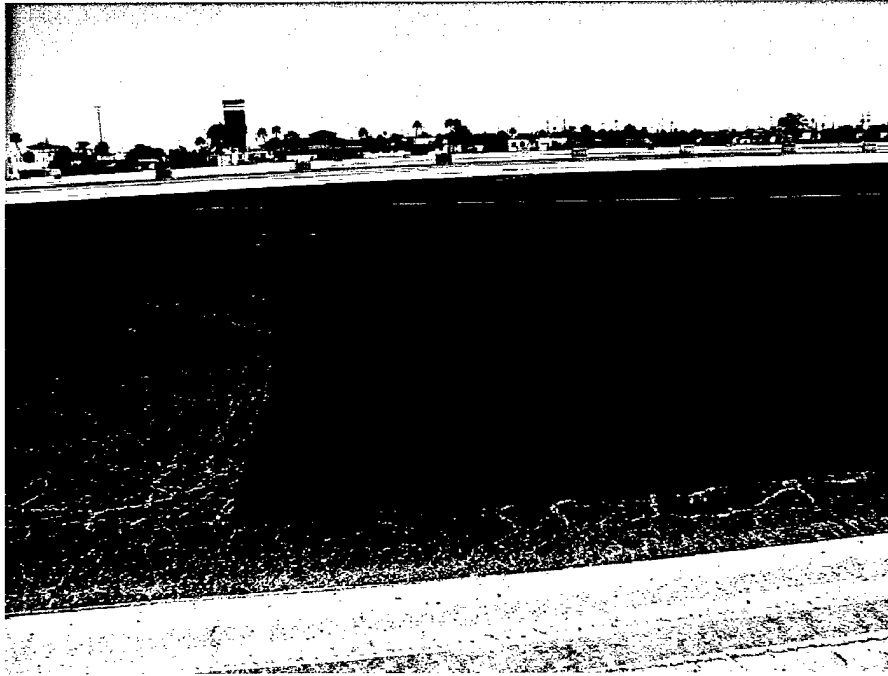
Figure 5. E-Krete surface in October 2000 at MacDill AFB. The adjacent pavement is coal tar that is approximately 14 years old and is severely deteriorated

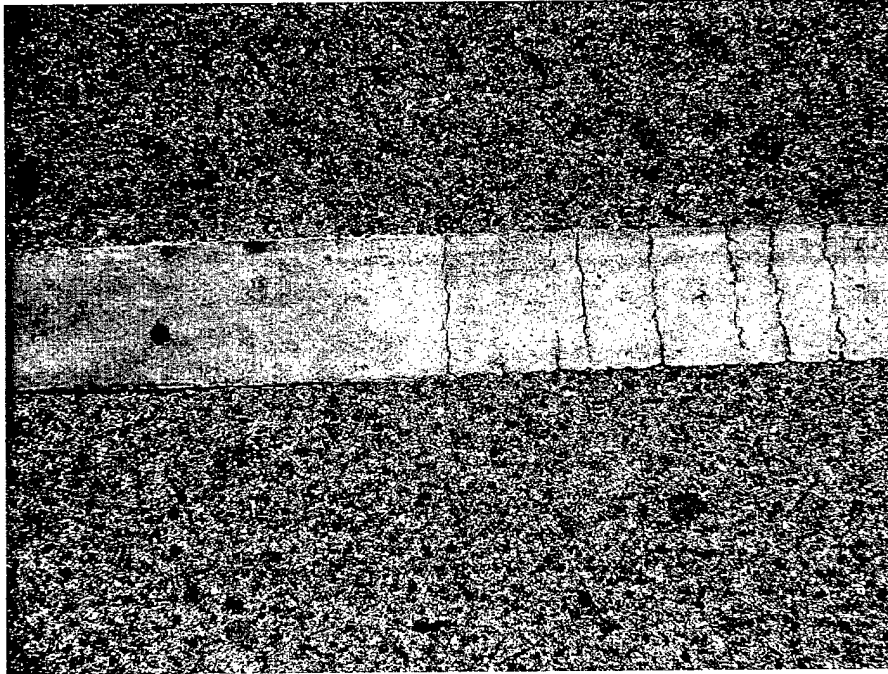
Figure 8. PermaStripe line at MacDill AFB in October 2000 after a full 2 years in service. Note the transverse cracking in the conventional airfield pavement marking paint. The marking paint is approximately 3 years old in this picture

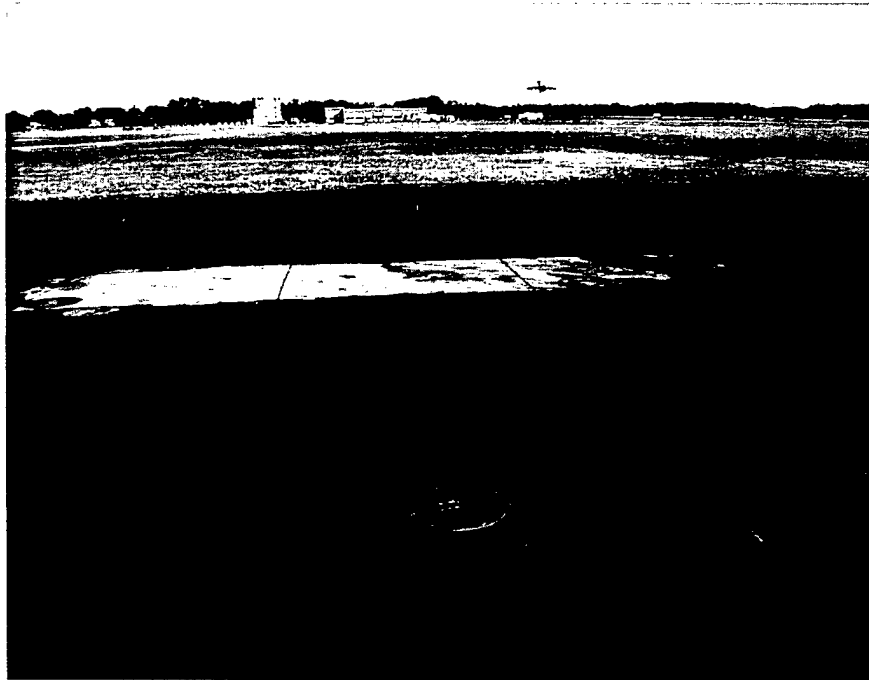
Figure 12. E-Krete and PermaStripe at Norfolk Naval Station. Note the severe hydraulic fluid staining around the concrete island. This area has been used repeatedly for servicing aircraft

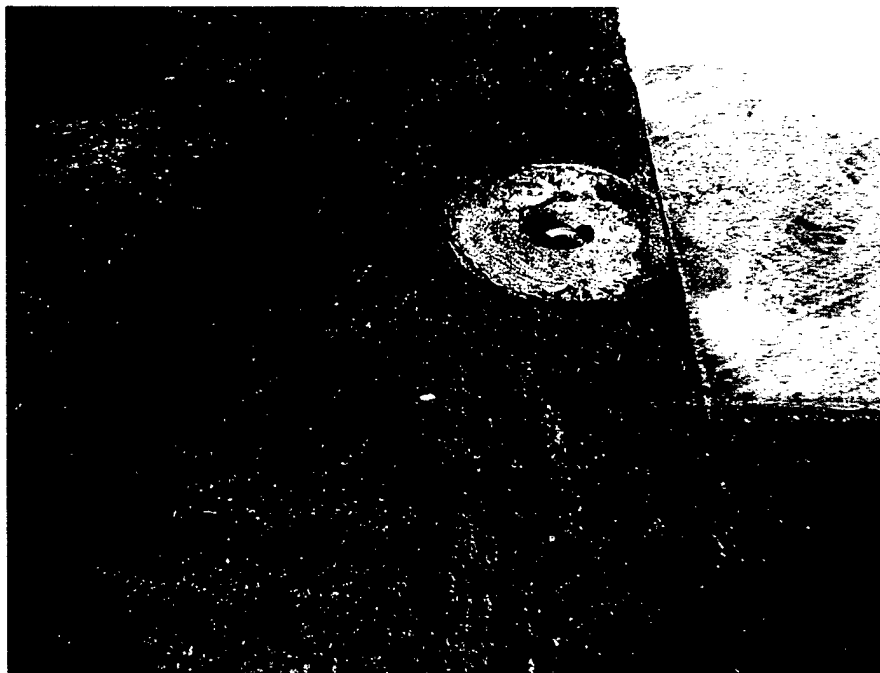
Figure 13. Closeup view of the E-Krete and PermaStripe at Norfolk Naval Station. The hydraulic fluid is literally pooled around the PermaStripe tie-down. Some delamination of the PermaStripe has occurred because of the ingress of hydraulic fluid under the surface of the PermaStripe where the asphalt and concrete meet

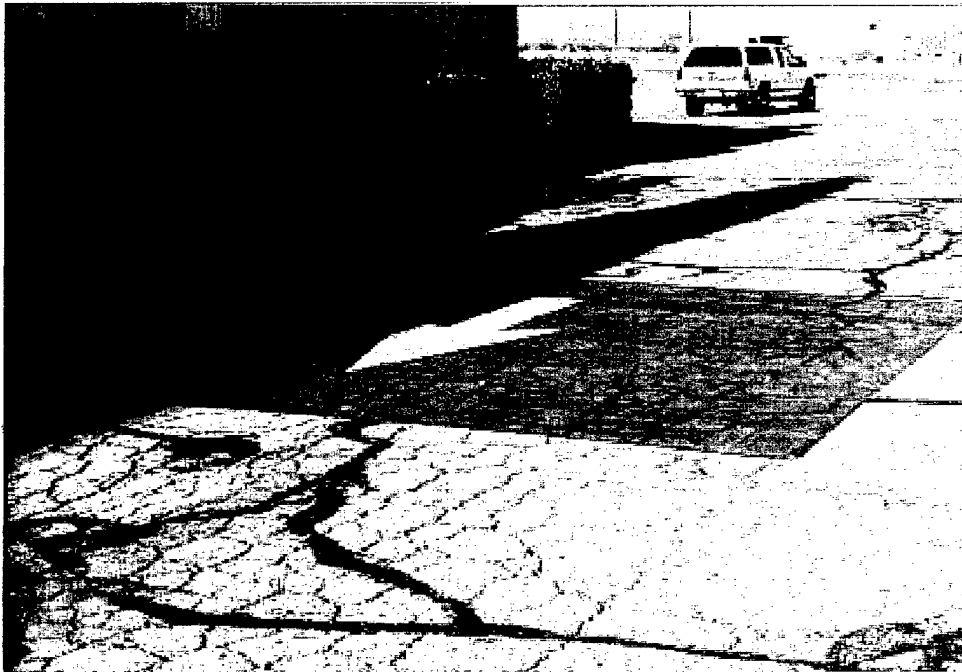
Figure 14. E-Krete and PermaStripe at Edwards AFB. Note the severely cracked asphalt surface upon which the E-Krete was placed. Although many of the cracks have reflected back up through the E-Krete, it is in much better condition than the asphalt with virtually no raveling, unlike the surrounding pavement

The condition of the E-Krete™ was excellent aside from the reflective cracks from the underlying asphalt. The reflective cracking is excessive but no distresses related to the E-Krete™ were noted. Some minor raveling from the crack faces had occurred where there is noticeable unevenness in the substrate and in areas where the underlying asphalt cracks were about ½ in. wide. Some cracks have also reflected through the white arrow. The color of the E-Krete™ is darker than the surrounding pavement and is holding the color well. There is a white arrow of PermaStripe™ in the middle of this section that was placed directly on top of the E-Krete™. This section receives car and light truck traffic only. Frictional resistance was not measured since traffic was present during the inspection. Adhesion tests conducted on the E-Krete™ section pulled up the underlying asphalt.

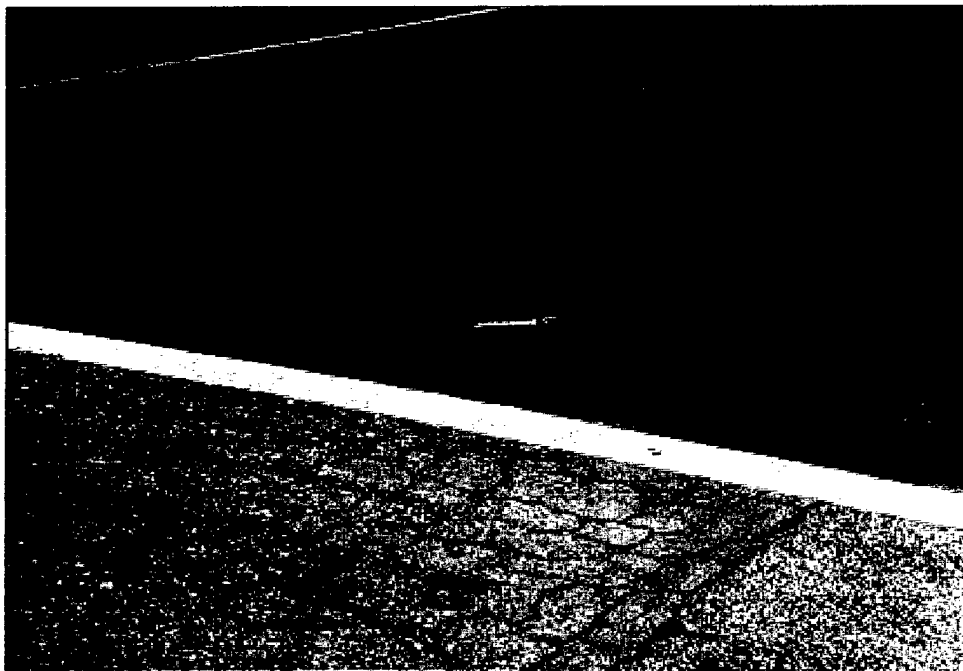
The overall condition of the pad is better than the surrounding pavement. A white discoloration is noticeable on the E-Krete™, in areas adjacent to hairline cracking. A similar condition was noted on one of the E-Krete™ sections at Forbes Field. There were only a few areas where raveling had occurred from the crack faces and these were in areas with large underlying cracks. Generally, most of the cracks vary from hairline up to 3 mm (1/8 in.). The largest cracks are up to 6 mm (1/4 in.) wide. These types of cracks, while widespread, did not cover the entire pad. The yellow center strip did not appear to have cracks and is holding color well with little apparent fading. All of the cracks were reflecting up from the underlying asphalt.

Figure 16. E-Krete and PermaStripe at North Island NAS. Note the severely cracked asphalt surface upon which the E-Krete was placed. Although many of the cracks have reflected back up through the E-Krete, it is in much better condition than the asphalt with virtually no raveling, unlike the surrounding pavement

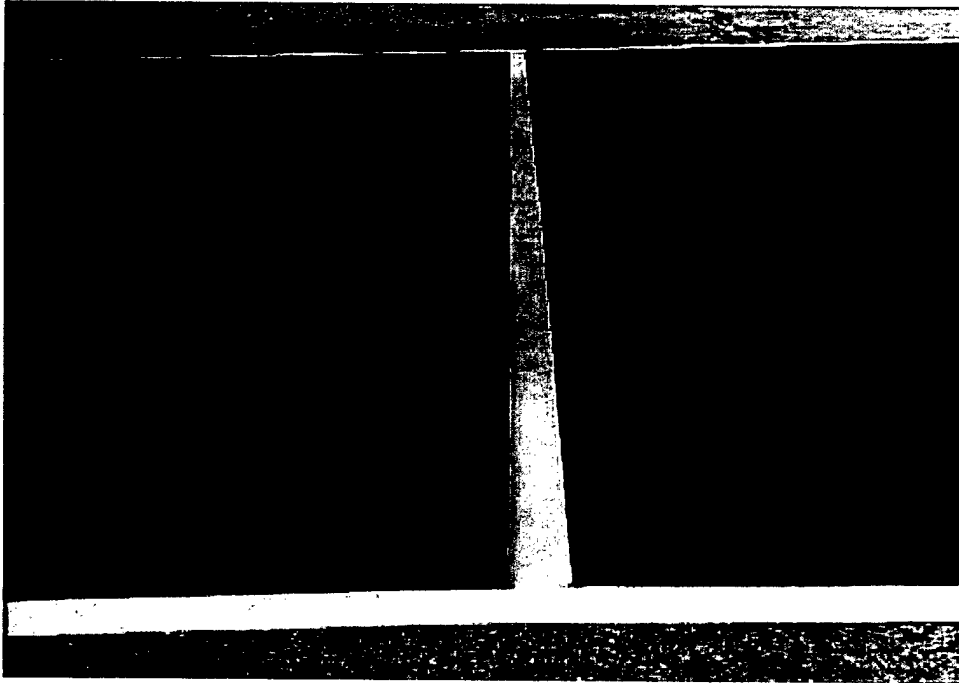
Figure 17. E-Krete and PermaStripe at North Island NAS. The PermaStripe has not faded and is holding its color well

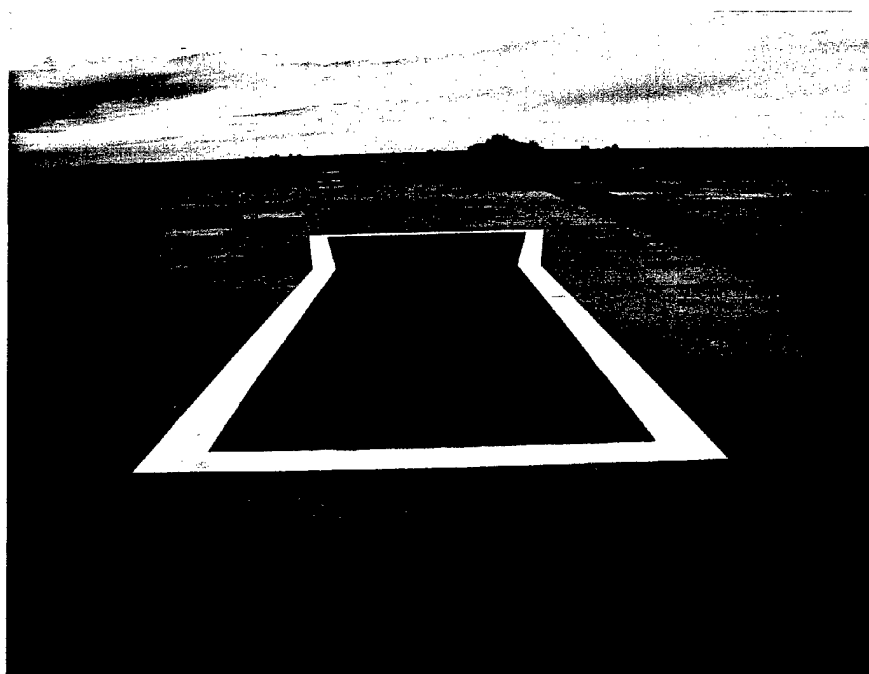
Figure 19. "Red Carpet" area in November 2000. Some fading of the red has occurred and reflective cracks are present, but overall, this section is in excellent condition

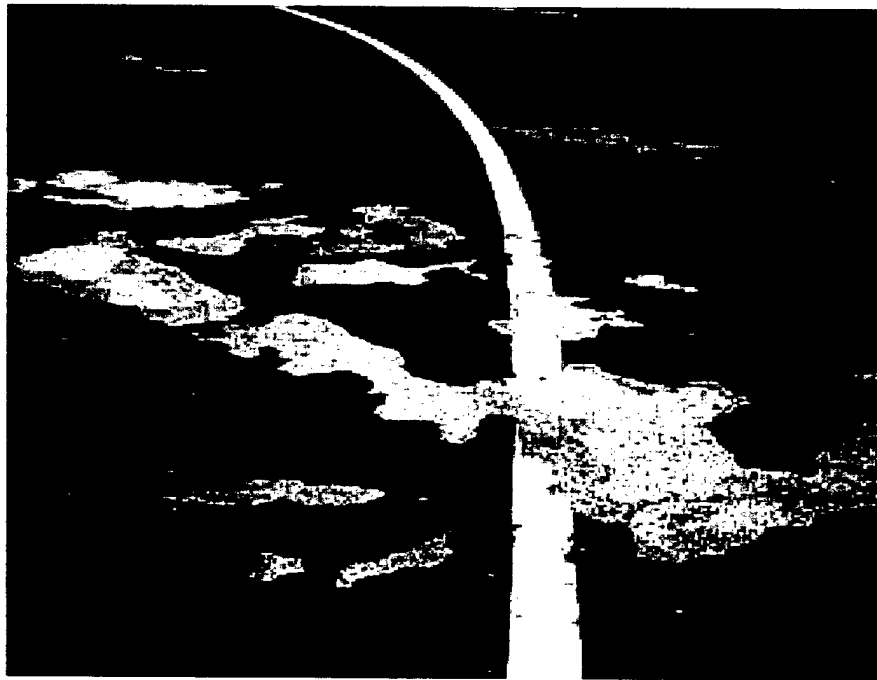
Figure 21. Severe delamination of existing coal tar surface (prior to E-Krete application)

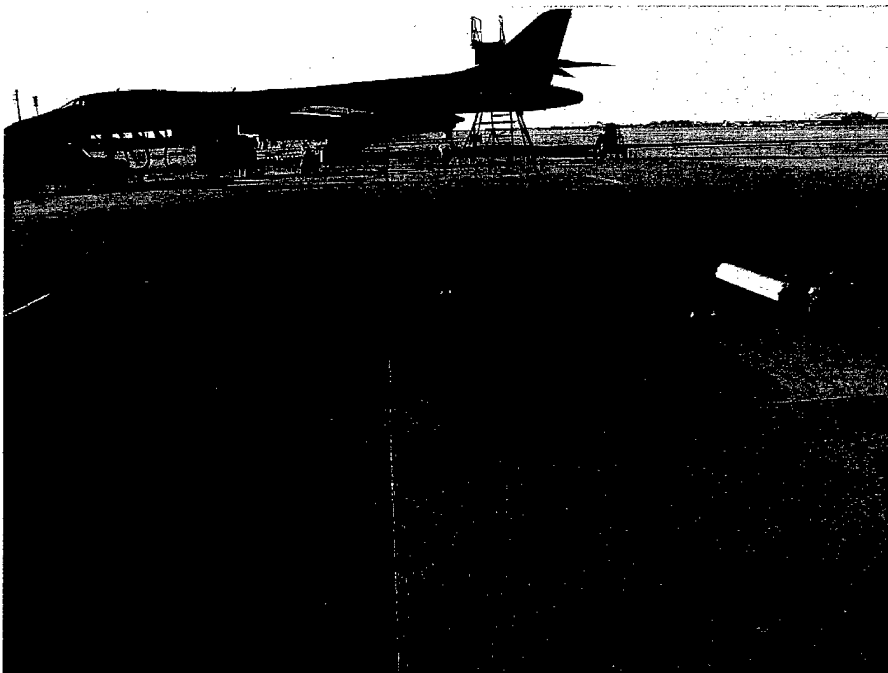
Figure 24. Overall view of B1B aircraft pad B10 in November 2000. As with B11, the E-Krete is completely soaked with aircraft hydraulic and turbine fluid and is in good condition.
